1 Case Study: – Prince William County Service Authority, VA

Table A Error! No text of specified style in document.-1. Project Summary

Objective	Identify a small drainage area exhibiting chronic infiltration problems to test the effectiveness of lateral sealing protocol, which would structurally rebuild the residential side sewer and eliminate ground water infiltration. Specific locations targeted for this work included both the PWCSA mainline to building lateral connection and the privately owned lateral, up to eighty (80) plus feet in length.
Method/Product	T-Liner® (LMK)
Time	Mar/Apr 2004
Location	Manassas, VA
Agency	Prince William County Service Authority – Wayne French, (703) 335-8981, french@pwcsa.org
CONTRACTOR MANUFACTURE	CONTRACTOR: Performance Pipe – Shawn Flannery (815) 433-0080, sflannery@ppi-liner.com MANUFACTURER: LMK Enterprises – Larry Kiest, (888) 433-1275, lmkliner@aol.com
Soil conditions	Two areas were targeted for the pilot project; both demonstrated seasonable high water table with permeable soils and the trench back fill.

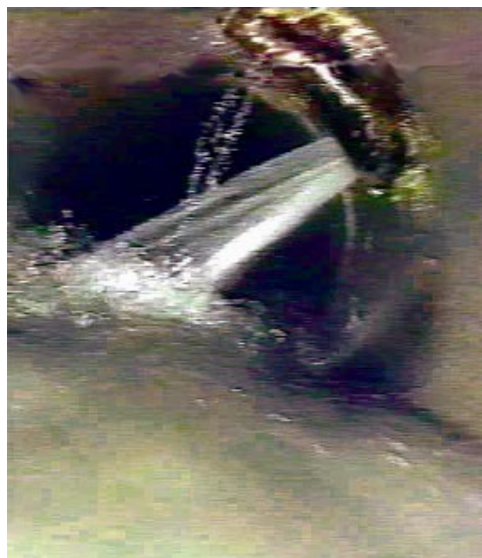
Table A Error! No text of specified style in document.-2. Prince William Service Authority, VA, 2003: Condition assessment of laterals

A lateral push camera was inserted into each lateral through cleanouts and directed towards the mainline and the house. All of the laterals made of Orangeburg materials had failed (allowed groundwater infiltration to occur) additionally all were demonstrating various levels of deformation and in seven cases the condition was so pronounced that it inhibited the cameras passage. Seven occurrences of this condition were identified. The contractor was able to re-round two of the pipes enough to allow passage of the camera as well as the CIPP materials. Five laterals were open-cut spot-repaired in ten to twelve foot long sections and replaced with sections of PVC pipe. The results of lateral CCTV inspection (Table A **Error! No text of specified style in document.**-2) clearly showed that all laterals needed rehabilitation.

Pipe type	Number of laterals	Condition:
Orangeburg	16	All pipes had failed with blistering and the pipe material was delaminating in layers.
Cast iron	2	Pipes had severe mineral buildup over time, which reduced their hydraulic capacity from 4" to 2" pipes. These pipes have reached the end of their life (40 years) and would continue to decay.
PVC	2	These pipes were in good condition but not the connection at the mainline.

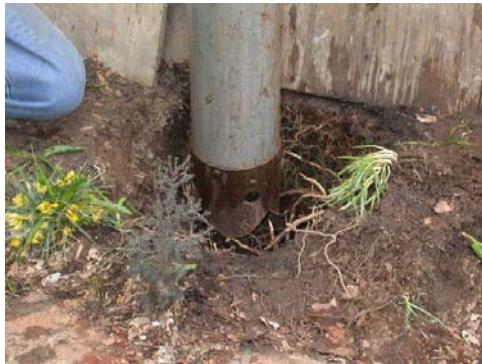
Figure A Error! No text of specified style in document.-1 Hydro excavating of the pit

Vacuum excavation was utilized to create access points which would allow for the remote connection of a lateral saddle assembly product. This saddle assembly snaps onto an existing lateral pipe. The lateral saddle system significantly reduces the amount of disruption (small foot print) when compared to a typical cleanout installations. The soil was cut with a water jet and vacuumed out with a 6" tube (connected to a truck). The pit size was about 18" in diameter. It took on average 60 minutes to complete one pit.

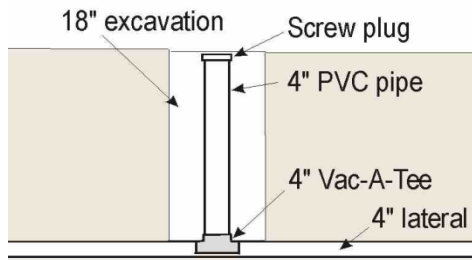
Figure A Error! No text of specified style in document.-2 Installation of

For each cleanout, a piece of 4" PVC pipe was used as a riser from the lateral. Attached to the lateral using a PVC saddle (4" VAC-A-TEE®) and coming up to grade. The water-tightness was accomplished by applying a special resin that cured in 30 minutes providing a structural seal.

new cleanouts

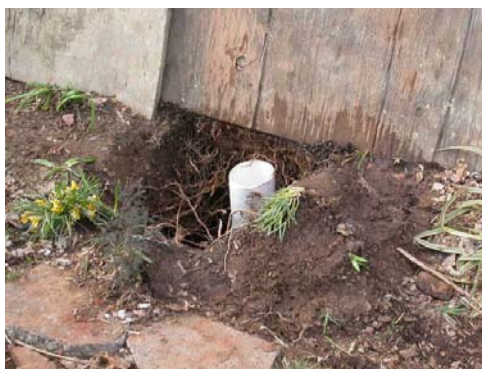
Figure A Error! No text of specified style in document.-3 VAC-A-TEE® Cleanout installed in the pit

The new cleanout assembly was filled with water performing a hydrostatic exfiltration test verifying, a non-leaking connection.

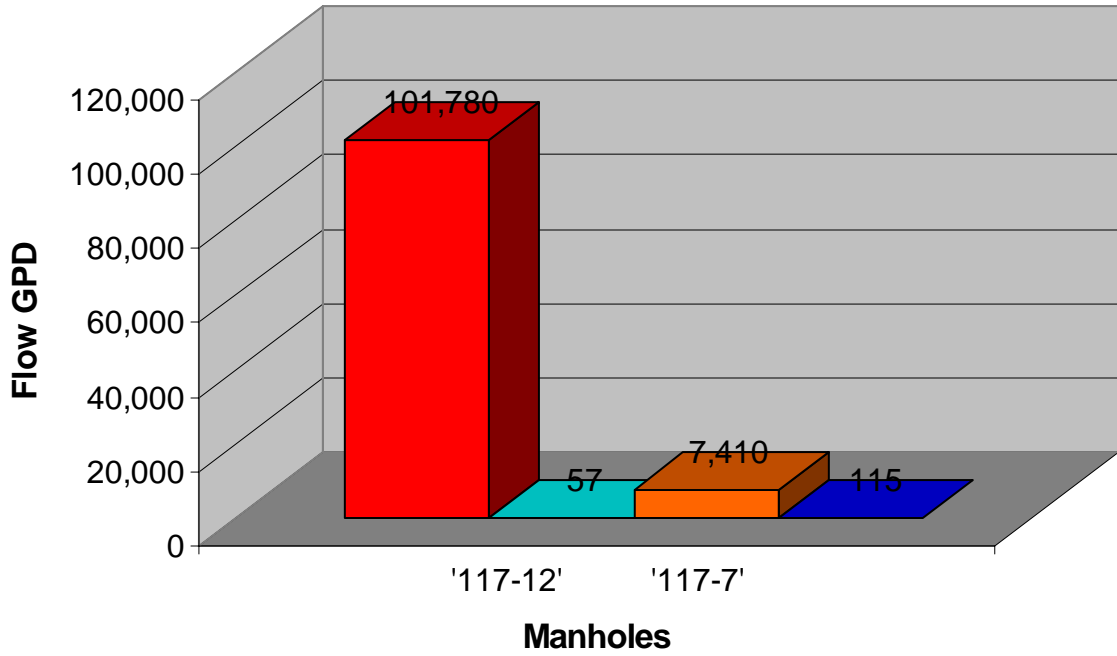
Amherst Drive/Amherst Court

- Amherst Dr/Yorkshire Ln 6/7/03 Before
- Amherst Dr/Yorkshire Ln 3/8/05 After
- Amherst Dr/Ct 6/7/03 Before
- Amherst Dr/Ct 3/8/05 After
