FIGHTING THE TIDE

**Irene McSweeney Woodfall, P.E.
Boston Water & Sewer Commission**

Installing and Rehabilitating Sewers Using Trenchless Techniques

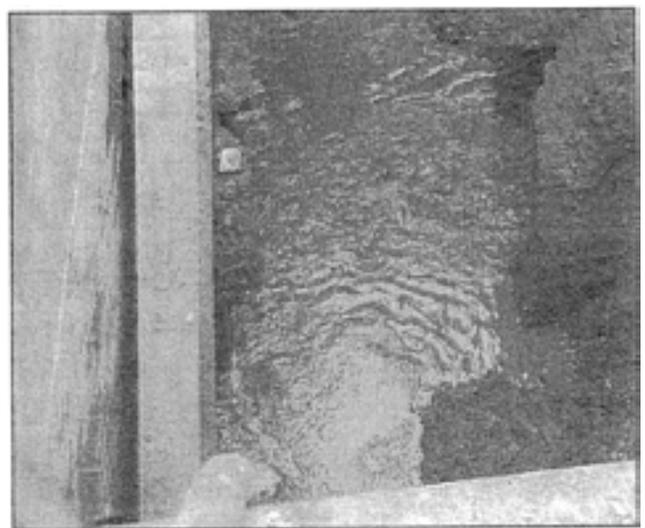
The project area is adjacent to the harbor and at high tide, a majority of the system is tidally influenced. At a full moon, spring tide, the tide is generally around elevation 11. At low tide, the tide ranges from elevation -2 to 2. However, during storm surcharges, the tide has been observed as high as 13. The sanitary sewer ranges from elevation 8 to elevation 3, therefore providing limited time to access the system with minimal tidal influence. (See Photo 5)

Photo 5. -Tidal Influence at Excavated Point Repair

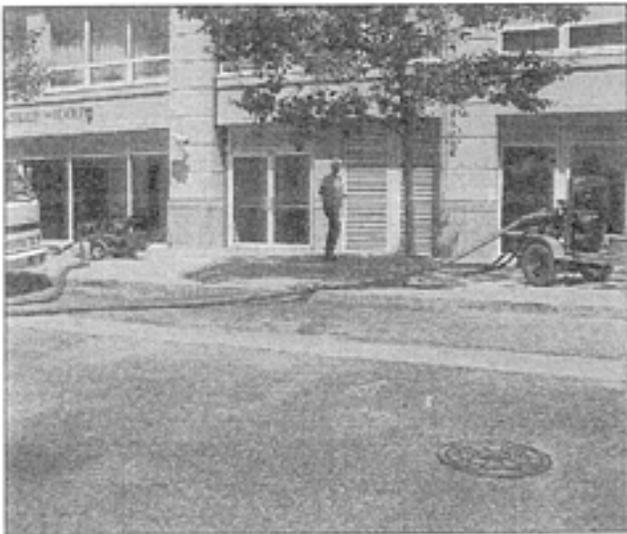
Photo 7. Bypass Pumping

With the television inspection complete, the contractor and subcontractor were required to become familiar with the flows in the tributary sewers and lateral connections. There were many customers that had substantial flow and individual bypass was required. (See **Photo 7**) The duration of the main line sewer liner as well as the time for the lateral liner needed to be evaluated. The failure to properly evaluate the flow could adversely affect the buildings by back-ups resulting in property damage. In addition to the sewer flow, the contractor and subcontractor had to evaluate the impact of the infiltration from both upstream and downstream, because the bypass pumps would need to consider the tides while the system was curing. In addition to the bypass pumping, the contractor installed weirs to control the flow. Lastly, the contractor needed to address flow while performing the manhole rehabilitation.

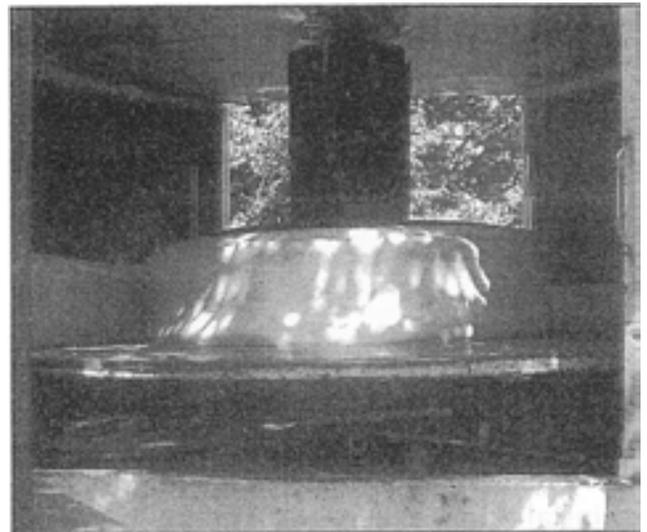
Photo 8. Liner Deformed in Truck

Miller Pipeline Corp. selected the EX Method of pipe rehabilitation. The polyvinyl chloride (PVC) resin pipe is deformed for insertion by heating in the pipe warmer trailer. Once the pipe is warmed the liner is prepared for insertion into the sewer system. (See **Photo 8**) Generally the liner was winched from one manhole to another, depending upon the length of the run, the longest being 500 feet. (See **Photo 9**) Once the liner reaches the destination point,

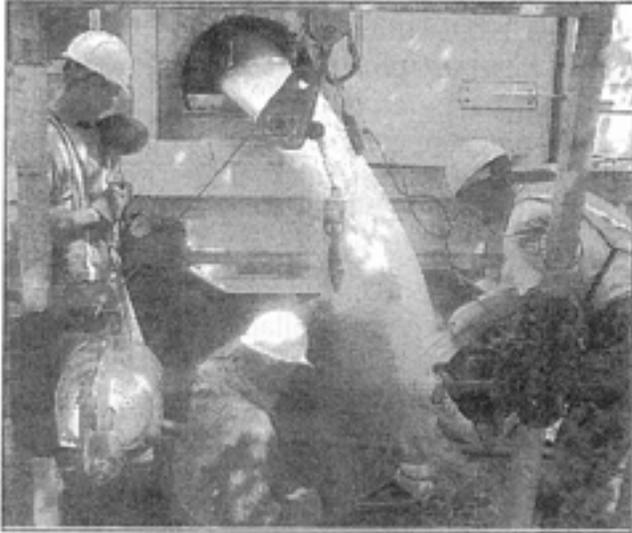
Photo 9. Liner Insertion

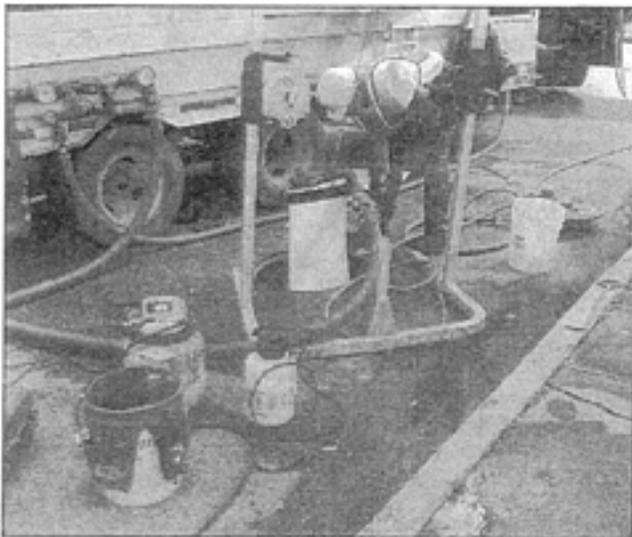
Photo 10. Preparation of Liner for Curing

generally another manhole, steam and pressure are introduced into the liner for expansion of the liner, which deforms to the shape of the conduit. **(See Photos 10 & 11)** Once totally deformed, the steam is stopped and pressure continues until the conduit cures and the PVC cools. Once completed the excess liner is cut and removed from the insertion and reception manholes. The liner is now ready to introduce flows. Depending upon the volume and the time required for the curing it may be necessary to deactivate the bypass system and

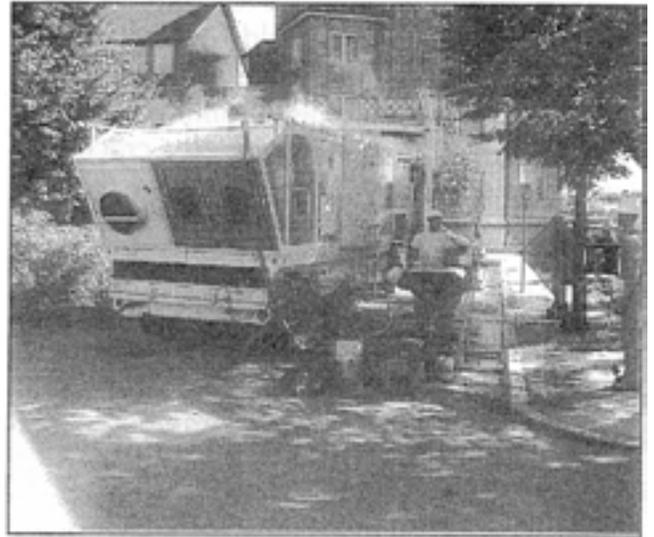
Photo 11. Steam Curing of Liner

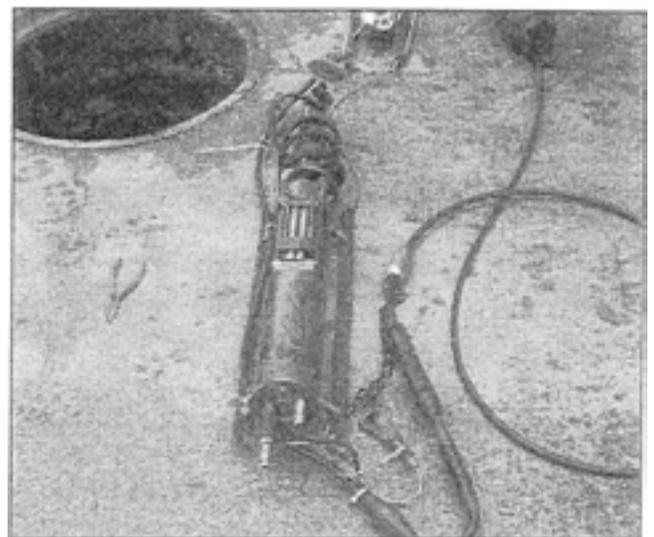
Photo 12. Reinstatement of Services

allow the system to be activated. This was complicated by the need to reopen the active services, which were also still subjected to the tidal influence. Both evaluation of the tidal influence was necessary in determining who required bypass. Each active service was reopened by remote controlled cutters, guided by television inspection. **(See Photo 12)** At times the activation of the services was delayed because of the tidal influence as well, which only heightened the importance of coordination. In larger systems, oftentimes the services are reinstated by workers entering the system.

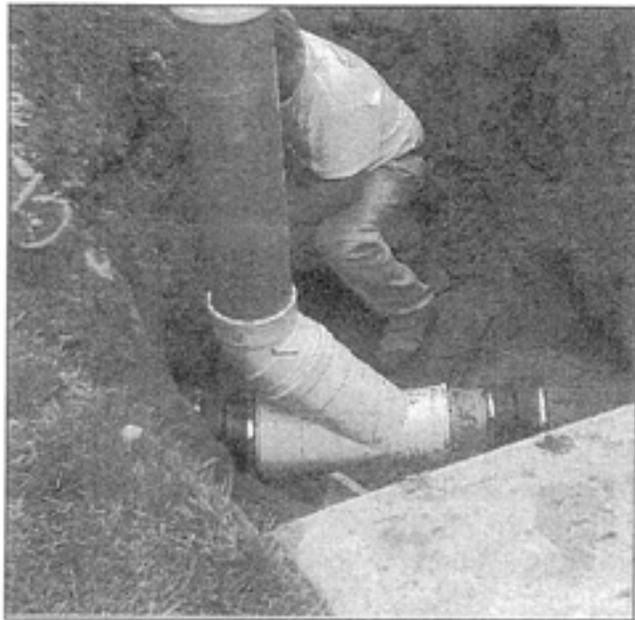
Photo 13. Access to Sewer Service

Miller Pipeline Corp. selected LMK Enterprises, Inc.'s T-Liner as they're proposed method. As required in the contract, the contractor excavated at each requisite liner and accessed the sewer lateral. (See Photo 13) The contract identified that the liner at a maximum would be twenty feet. It became apparent at a few locations that the lateral, generally six inches in diameter, would need to be extended because the depth at twenty feet was still tidally influenced. A unit price for each foot beyond the twenty feet was negotiated and agreed to and paid under a change order.

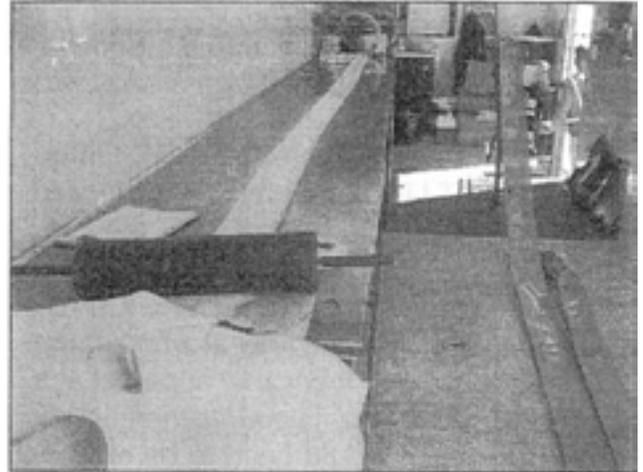
Photo 14. Sewer Lateral Liner Impregnated

The actual process was now ready to commence. The liner is inspected for defects and for proper size. The liner was inspected to confirm there were no defects or rips. The length of the liner was final checked to ensure that the requisite length was provided whereas no seams are allowed. The liner was now impregnated with the resin. The resin was introduced at one end and pressed through the liner with a roller to ensure that it was uniformly applied. **(See Photo 14)** The resin was thoroughly impregnated by a vacuum process removing all air and pulling the resin into the liner. The main line portion of

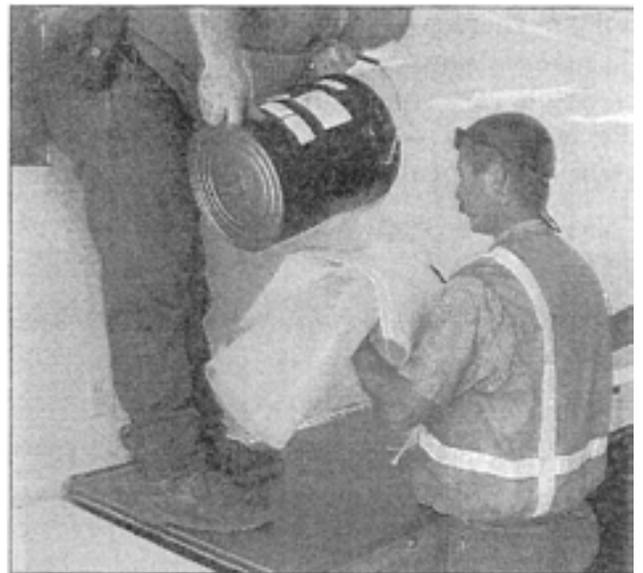
Photo 15. T-Line Impregnated

the liner was also impregnated with the resin to ensure full saturation. **(See Photo 15)** This is critical to provide the requisite bond within the system. The color of the liner, originally white is now tan as a result of the impregnation, a visible way to inspect the full penetration of the resin into the liner.

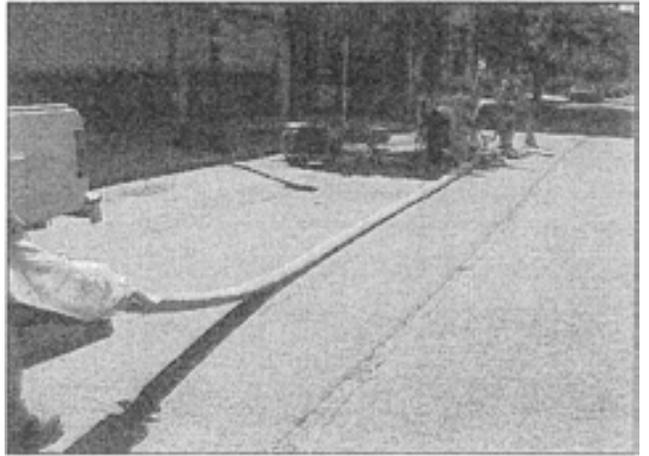
Photo 18. Inversion

As part of this assembly the launching mechanism for the lateral insertion was integral. The insertion commenced and watched via two remote television cameras, one in the main line sewer and one in the lateral. (See **Photo 18**) The assembly is brought to the lateral and aligned with the lateral. The liner had been previously marked to assist in the alignment process. (See **Photo 19**) The assembly was protected during the pull by the rotating skid system. It was important that the liners are not contaminated by dirt or debris as part of the insertion; the dirt could impact the integrity of the bond to the host pipe. (See **Photo 20**)

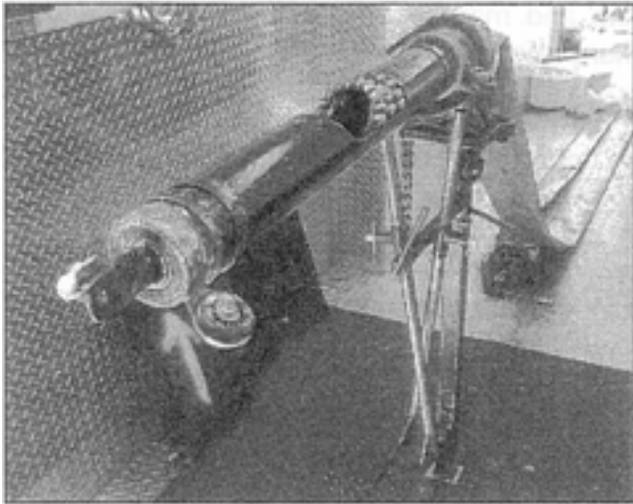
Photo 16. Lateral Liner

The liner assembly was now ready for installation into the lateral. The liner was attached to the inversion bladder, which was attached into the system by a winch, previously installed and ready for the process. **(See Photos 16 & 17)**

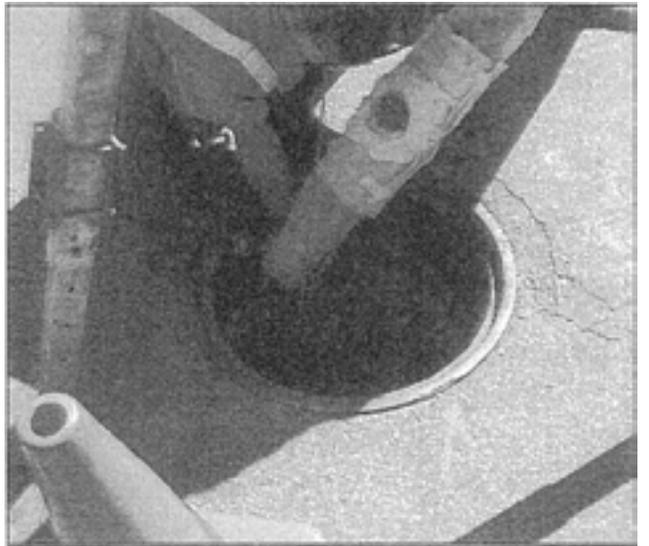
Photo 19. Lateral Mark

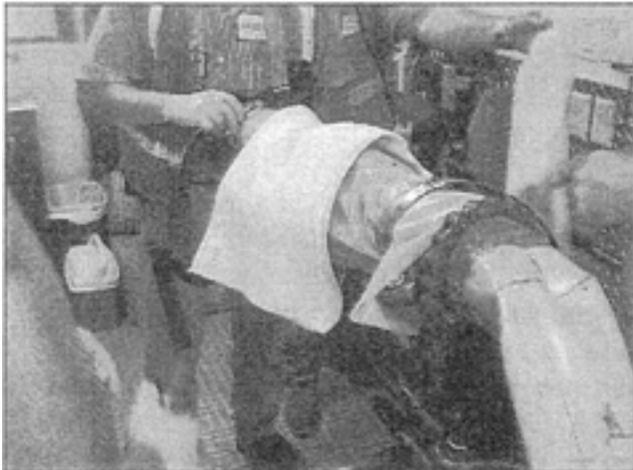
Photo 17. Main Line T-Liner Attached to Lateral Liner

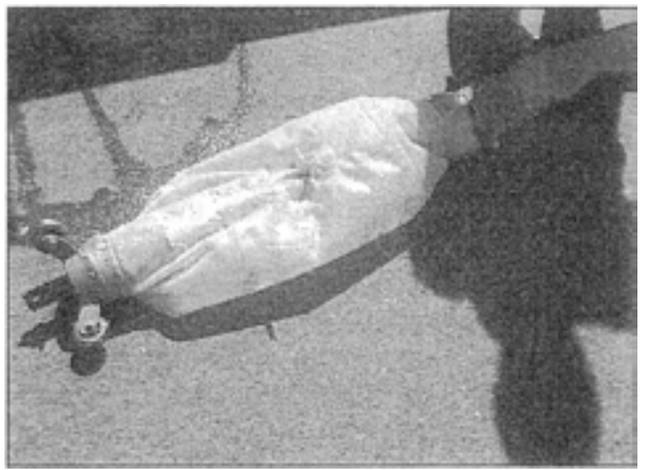
Photo 20. Insertion Unit
