1 Case Study: – Prince William County Service Authority, VA

Table A Error! No text of specified style in document.-1. Project Summary

Objective	Identify a small drainage area exhibiting chronic infiltration problems to test the effectiveness of lateral sealing protocol, which would structurally rebuild the residential side sewer and eliminate ground water infiltration. Specific locations targeted for this work included both the PWCSA mainline to building lateral connection and the privately owned lateral, up to eighty (80) plus feet in length.
Method/Product	T-Liner® (LMK)
Time	Mar/Apr 2004
Location	Manassas, VA
Agency	Prince William County Service Authority – Wayne French, (703) 335-8981, french@pwcsa.org
CONTRACTOR MANUFACTURE	CONTRACTOR: Performance Pipe – Shawn Flannery (815) 433-0080, sflannery@ppi-liner.com MANUFACTURER: LMK Enterprises – Larry Kiest, (888) 433-1275, lmkliner@aol.com
Soil conditions	Two areas were targeted for the pilot project; both demonstrated seasonable high water table with permeable soils and the trench back fill.

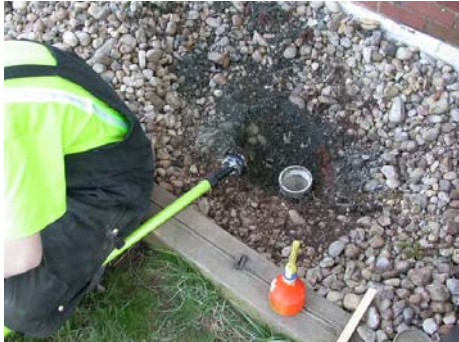
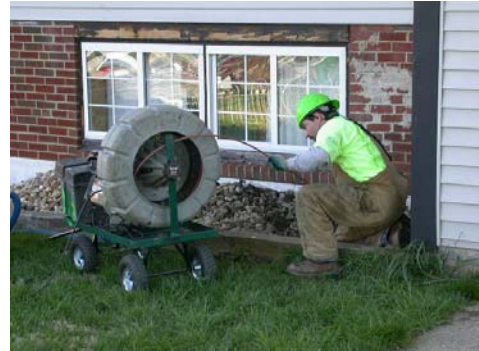
Figure A Error! No text of specified style in document.-3 VAC-A-TEE® Cleanout installed in the pit

1. Cleanouts provided access to clean and inspect the lateral pipes. Once the lines were prepared and ready for insertion, a camera was inserted from the cleanout to the main pipe providing accurate robotic positioning of the main/ lateral lining. The camera inserted from the cleanout also allowed the inversion process to be documented on video recording equipment.

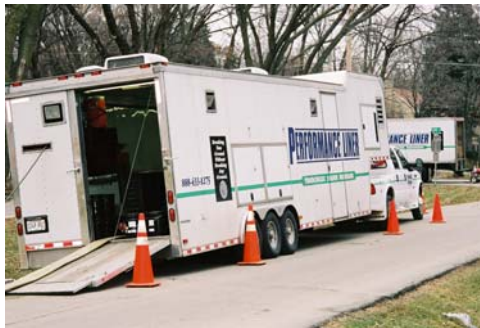
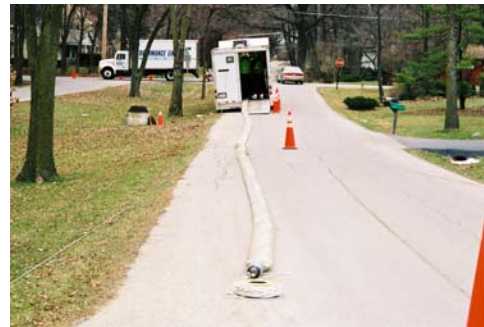
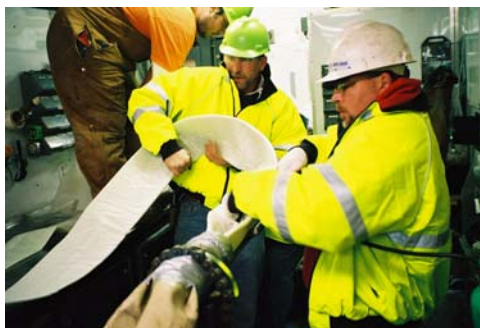
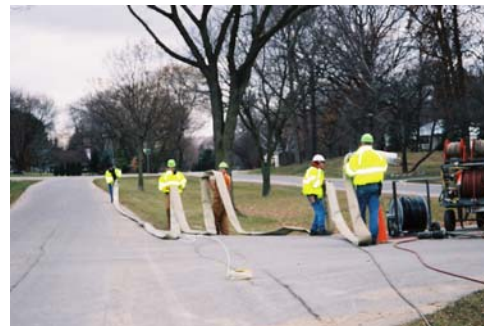
2. A mobile wet-out unit was used to vacuum impregnate the T-shaped liners with a thermo-set resin. The resin saturated materials were then loaded into a one-hundred foot long, flexible inversion launching device.

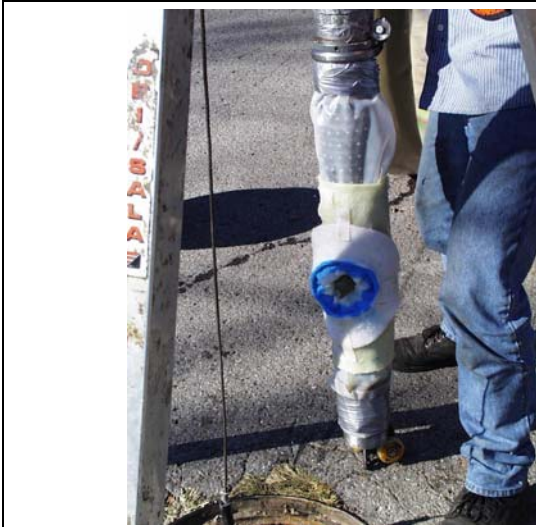
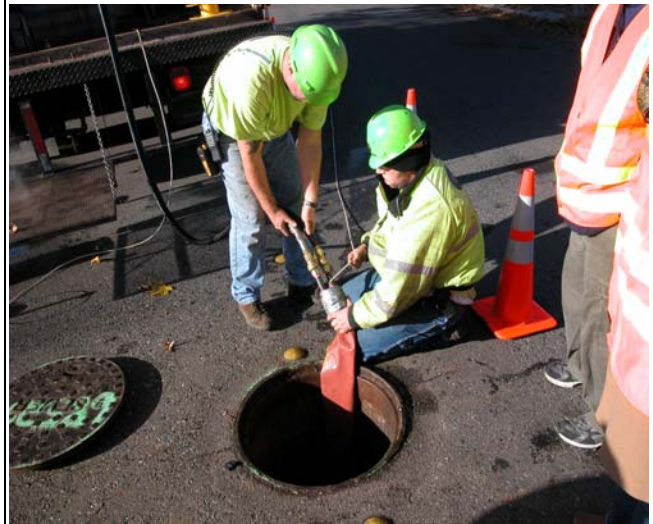
3. The installation assembly is towed through the main pipe and robotically positioned at the main to lateral connection. Air pressure was applied causing the liner and bladder to invert up into the old lateral pipe, on some laterals as far as 85 feet.

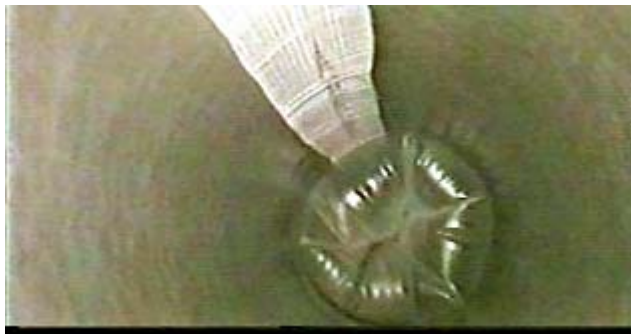
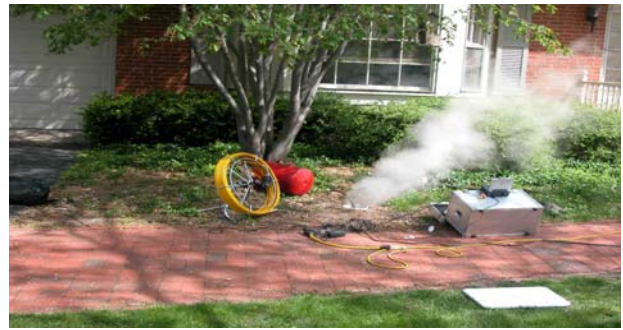
4. Once positioned, the felt tube materials were inverted with air pressure and held tight against the old lateral pipe. Hot air was mixed with the ambient air, providing a quick resin curing system. Liners in lengths of 85 feet were cured in as little as 30 minutes.

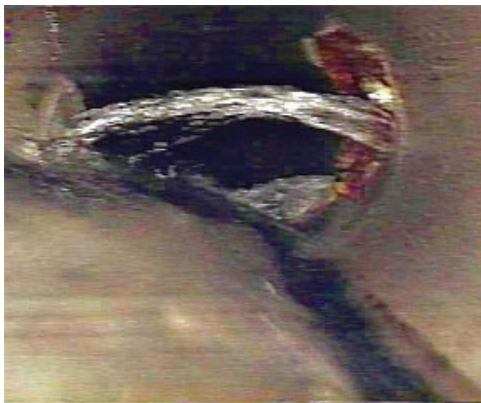
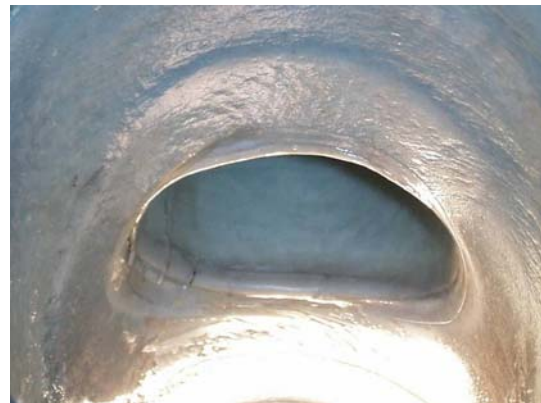
5. The finished product provided a one-piece main/ lateral composite with a full circle 16 inch long sleeve in the mainline. The materials are continuous in length from the main to the upper end of the lining which was adjacent the house foundation.

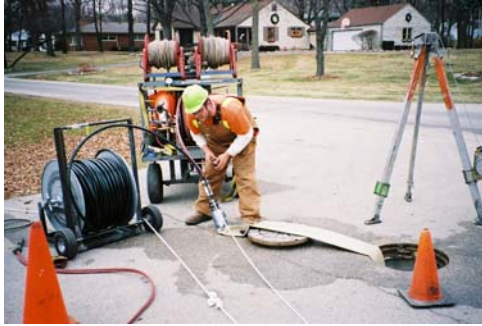
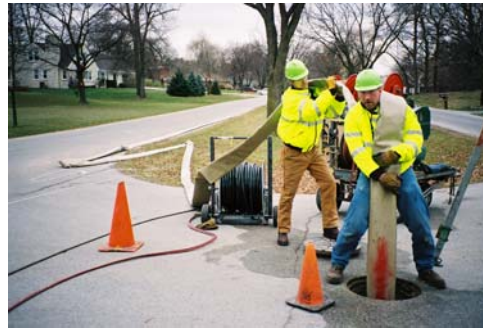
6. Once cured, the installation assembly unit (launcher) was removed and process was repeated for the next residence. Aside from some unfortunate electrical problems with the Illinois contractor's boiler, they were able to complete an installation every 2.5 hours.
