Siphon Spot Repairs in Tampa

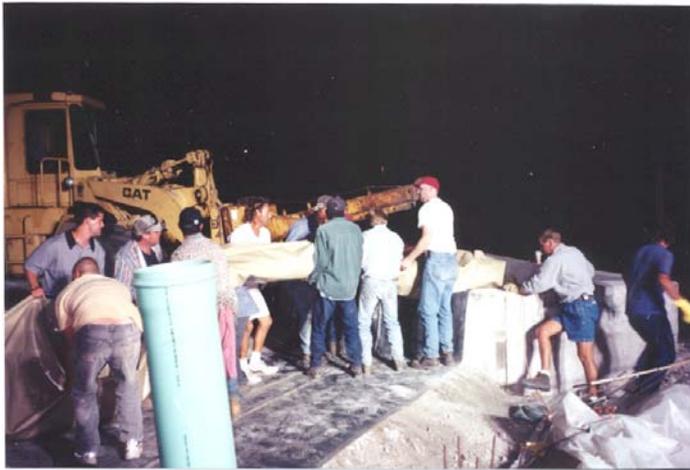
The liners required a lot of manpower to manually position the large inversion tubes. One 36-inch x 20-foot repair contained 775 pounds of resin plus the lining tube and inversion launch tube for a total weight of nearly 1,000 lbs. The liners were vacuum impregnated onsite inside of a refrigerated semi trailer. A translucent inversion bladder surrounds the lining tube.

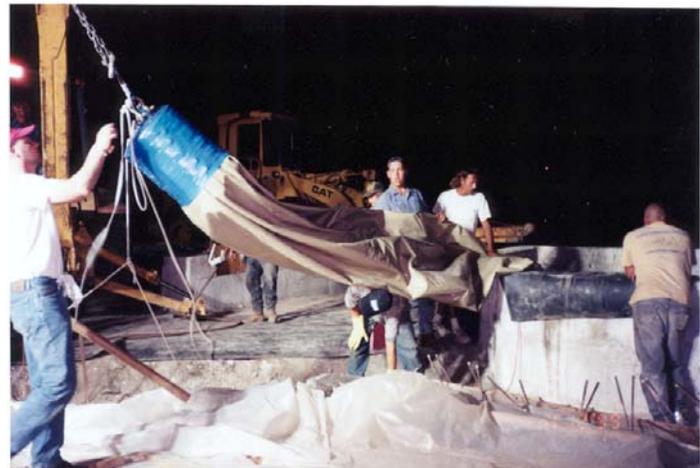
Once impregnated, the liner /bladder assembly was loaded into a launching device and connected to a source of compressed air. This type of sectional lining is unique with it's launching device that keeps the resin clean and contained. The delivery system uses an inversion installation similar to manhole to manhole systems. The inversion delivery system allows full resin migration.

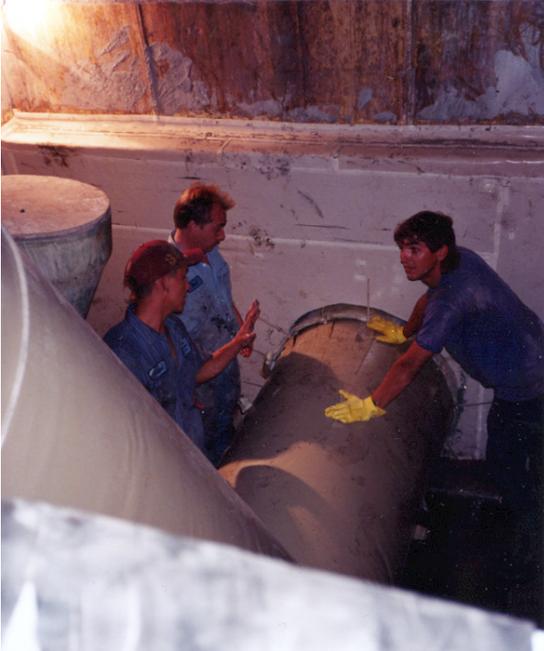
However, the resin contacts the pipe only when it is positioned at the point of repair. The linings were positioned at the beginning of the pipe at the face of the vaults wall. Air pressure was introduced into the launch tube causing the lining to invert into the damaged section of pipe. The linings were each cured within 3 hours from the time the liners were impregnated.
